**EXPERIMENTAL AND NUMERICAL INVESTIGATION ON THE VISITAZIONE  
CHURCH IN POGGIO PICENZE (AQ)**

**ABSTRACT**

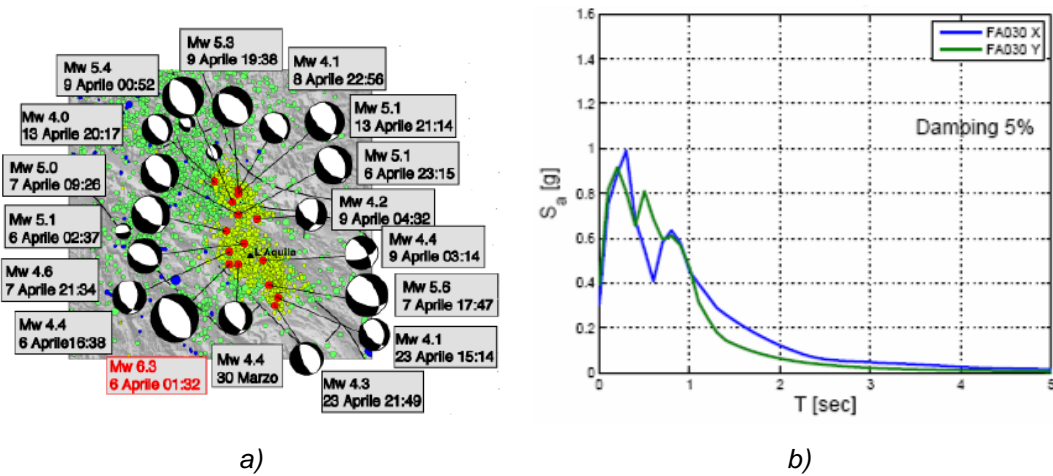
a) b)  
**Fig 2. Sequence of seismic events occurred in the L'Aquila district (a) and elastic acceleration spectrum 4.3 Km far from the epicentre (b)**

L'Aquila earthquake was an *exceptional* event, since the maximum recorded acceleration within the epicentral area was larger than PGA of the elastic spectra given by the Italian Code (M. D.,

2008) (Fig. 2b). Furthermore, it was a *near-field quake*, characterised by a considerable value of the vertical acceleration component. Finally, local amplification effects, due to the particular soil structure, contributed to amplify seismic waves.

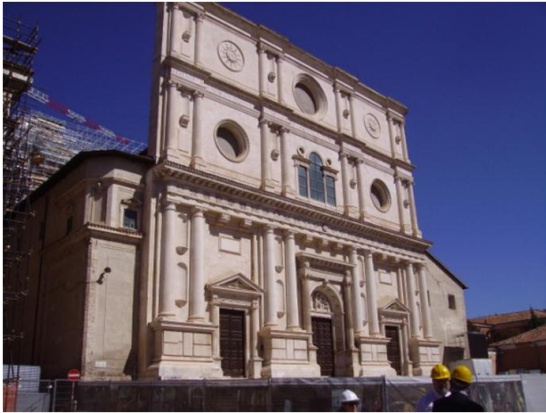
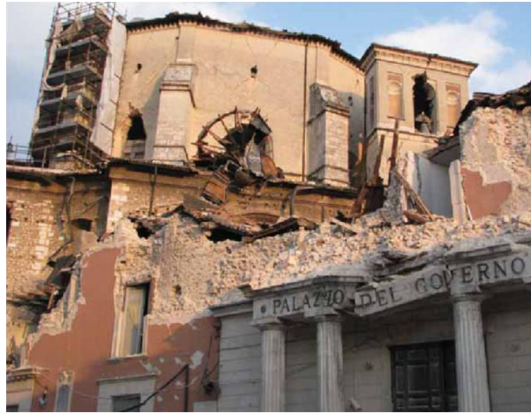
The Basilica of St. Bernardino

The Government Palace

**Fig 3. Monumental buildings of L'Aquila after the earthquake**

L'Aquila and the surrounding districts suffered significant damages to historic buildings. In particular, the historic centre of L'Aquila, which in English means "The Eagle", was partially destroyed. The built up heritage of this city is represented by churches and monuments, which include the Fountain of the Ninety-Nine Spouts, the 16<sup>th</sup> century Spanish Castle, the Basilica of St. Bernardino, the Church of St. Massimo, the Church of St. Mary in Collemaggio and the Government Palace (Fig. 3).

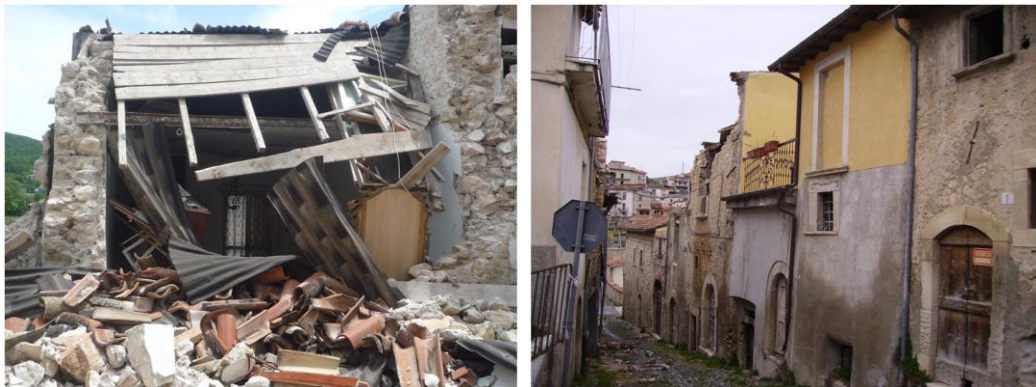
**Fig 6. Damages occurred in the historic centre of Poggio Picenze after the 2009 L'Aquila earthquake**

Consequences of 2009 L'Aquila earthquake were dramatic, since 5 people died and significant damages to buildings of the historical centre were recorded (Fig. 6).

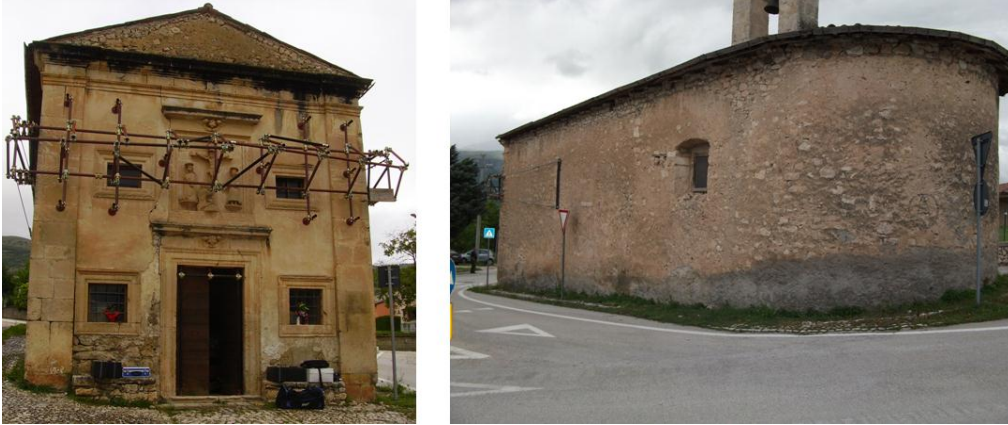
**Fig 7. The *Visitazione* church: external views**

The *Visitazione* church, located in the historic centre of Poggio Picenze, may be considered one of the most important monumental building of the town, because of its historic, artistic and sacred value. This small chapel (Fig. 7) was built probably between the 14<sup>th</sup> and 15<sup>th</sup> century and it was enlarged in 1832, as declared within an internal biblical epigraph.

The main façade contains elegant architectural decorations typical of the Romanesque- Aquilano style. Due to the earthquake, this façade shown an out-of-plane overturning mechanism, actually prevented by an appropriate retaining steel system (Fig. 7), which produced heavy cracks between longitudinal walls and the same façade wall. Also, shear and vertical in plane cracks have been perceived on the façade wall, they being graphically reported in Figure 10.

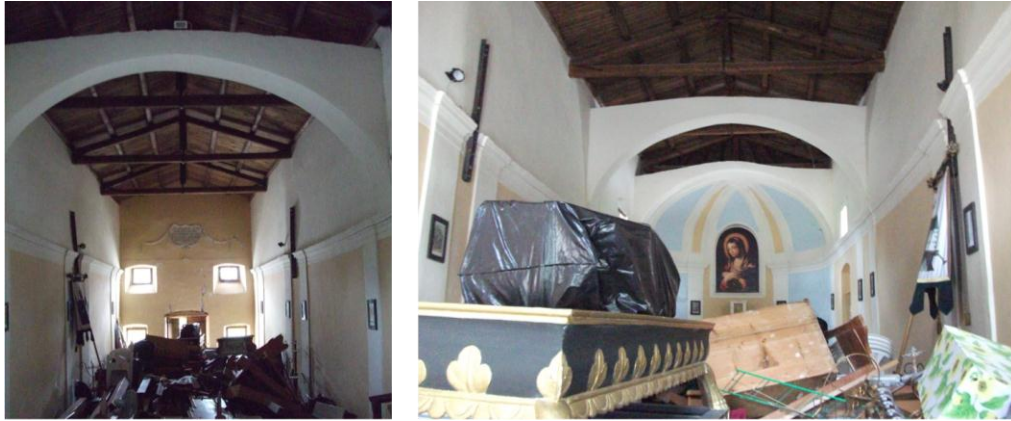
**Fig 9. The *Visitazione* church: internal views**

The church has a rectangular shape with a 18 m long and 6 m large unique nave (Fig. 8). The building exhibits a local stone masonry structure surmounted by a wooden pitched roof covered by clay tiles, probably rebuilt in 1980 after the collapse of the original one. In particular, the roofing main structure consists of cherry-wood trusses (200 mm x 200mm cross-section) and purlins (100mm x 100mm cross-section). Internal views of the church are illustrated in Figure 9.

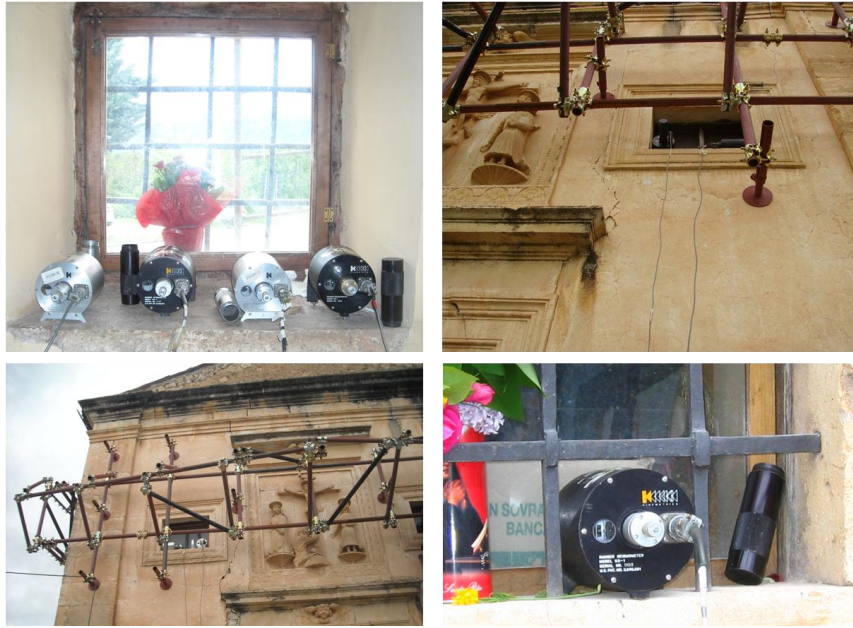
**Fig 11. The used seismometers (Ranger type)**

The instrumentations used by the IZIIS laboratory to carry out ambient vibration test includes the following equipments: three Ranger type seismometers (Fig. 11) and a Kinemetrics product for ambient vibration measurements and a Four Channel Signal Conditioner for filtering and amplifying the measured signals (Fig. 12).

The seismometers (Fig. 11) measure the vibration signals recorded in different point of the structure. Since the input – output correlation is not a priori noted, a steady point must be fixed as a Reference Point (RP), in order to normalise each measured point as respect to the RP amplification and, therefore, to identify the global dynamic response. Afterwards, the amplified and filtered signals from the seismometers is collected by a high-speed data acquisition system, which transforms the analogue signals into digital ones. PC and special software for online data processing were used to plot the time histories of the recorded velocities together with the Fourier Amplitude Spectra (FAS) of the response at each measured point.

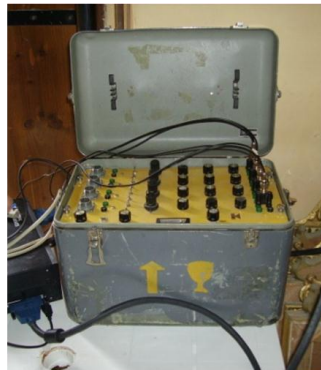
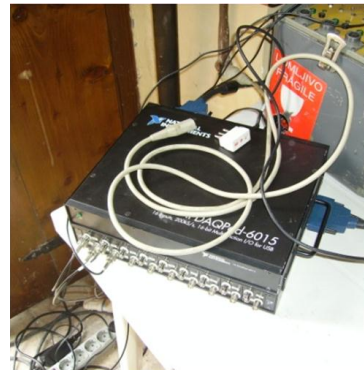
Kinometrics product

Four Channel Signal Conditioner

High-speed data acquisition system **Fig**

**Fig 12. The test set-up for ambient vibration tests**

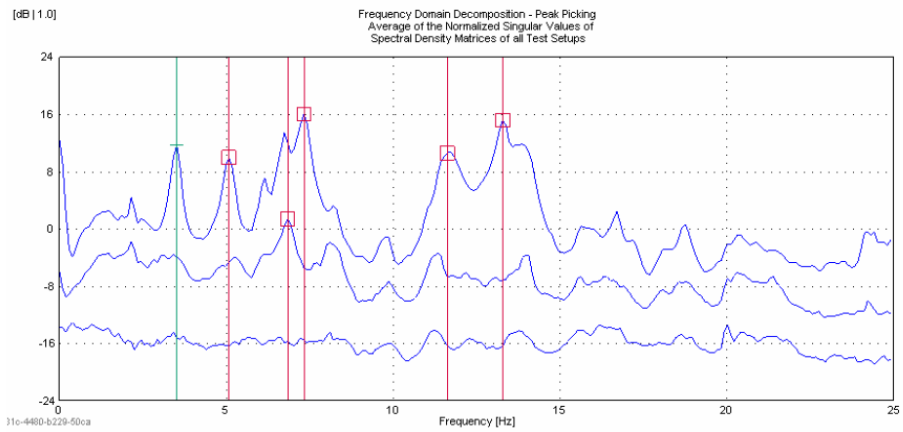
**Fig 14. Peak-picking of the dominant frequencies**

Six vibration modes were identified from the analysis of the complete set of data representative of the entire building. The peak-picking of dominating frequencies in the obtained spectrum is depicted in Figure 14.
